## SiDet Bump Bond Results for the First Five RTI Production Plaquettes

(Dated: July 26, 2006)

This document describes the results of several different bump bond tests performed at SiDet on the first five RTI production plaquettes. Good agreement is evident between the light and forward bias tests performed at SiDet and the light test performed at Purdue. The quality of bump bonds on these plaquettes appears to be quite good.

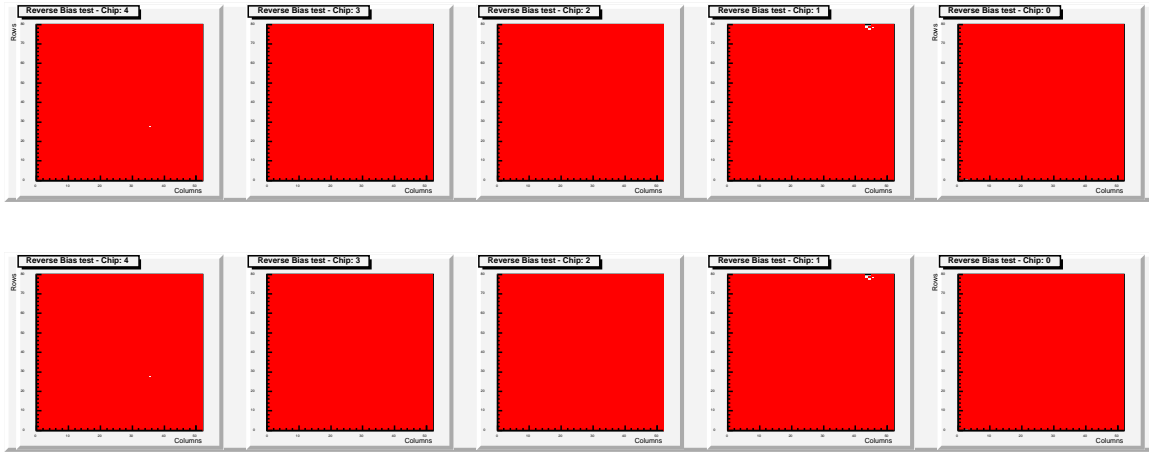
FIG. 2: Forward bias test results for P\_1x5L\_017\_C. The top plot was performed at  $+20^{\circ}$  C and the bottom plot was performed at  $-15^{\circ}$  C.

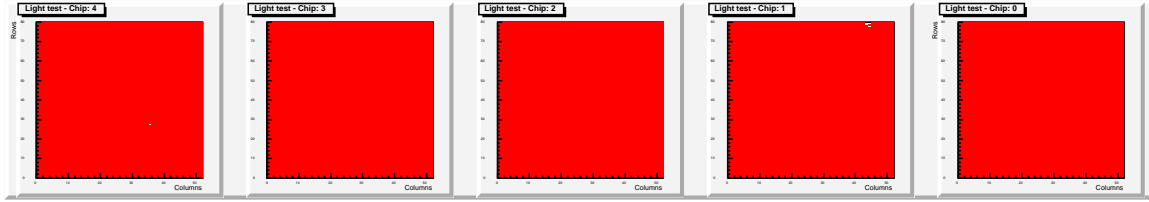
FIG. 3: SiDet light test results for P\_1x5L\_017\_C. The test was performed at  $+20^{\circ}$  C.

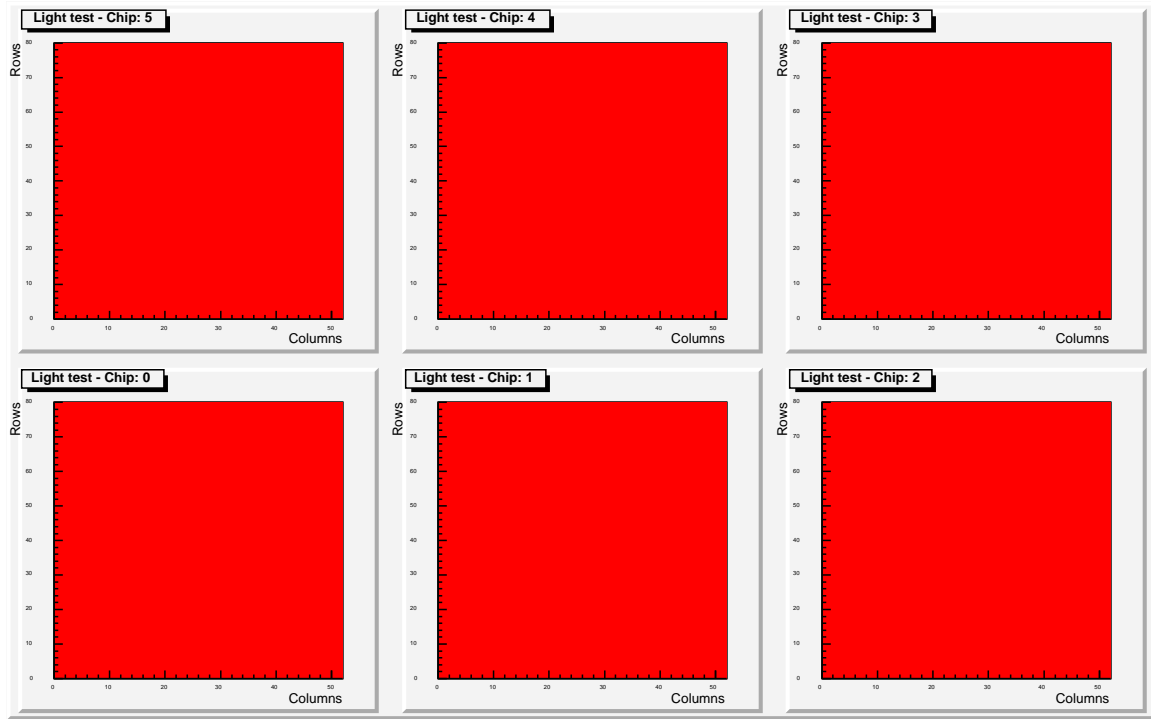
FIG. 6: SiDet light test results for P\_2x3B\_017\_C. The test was performed at  $+20^\circ$  C.

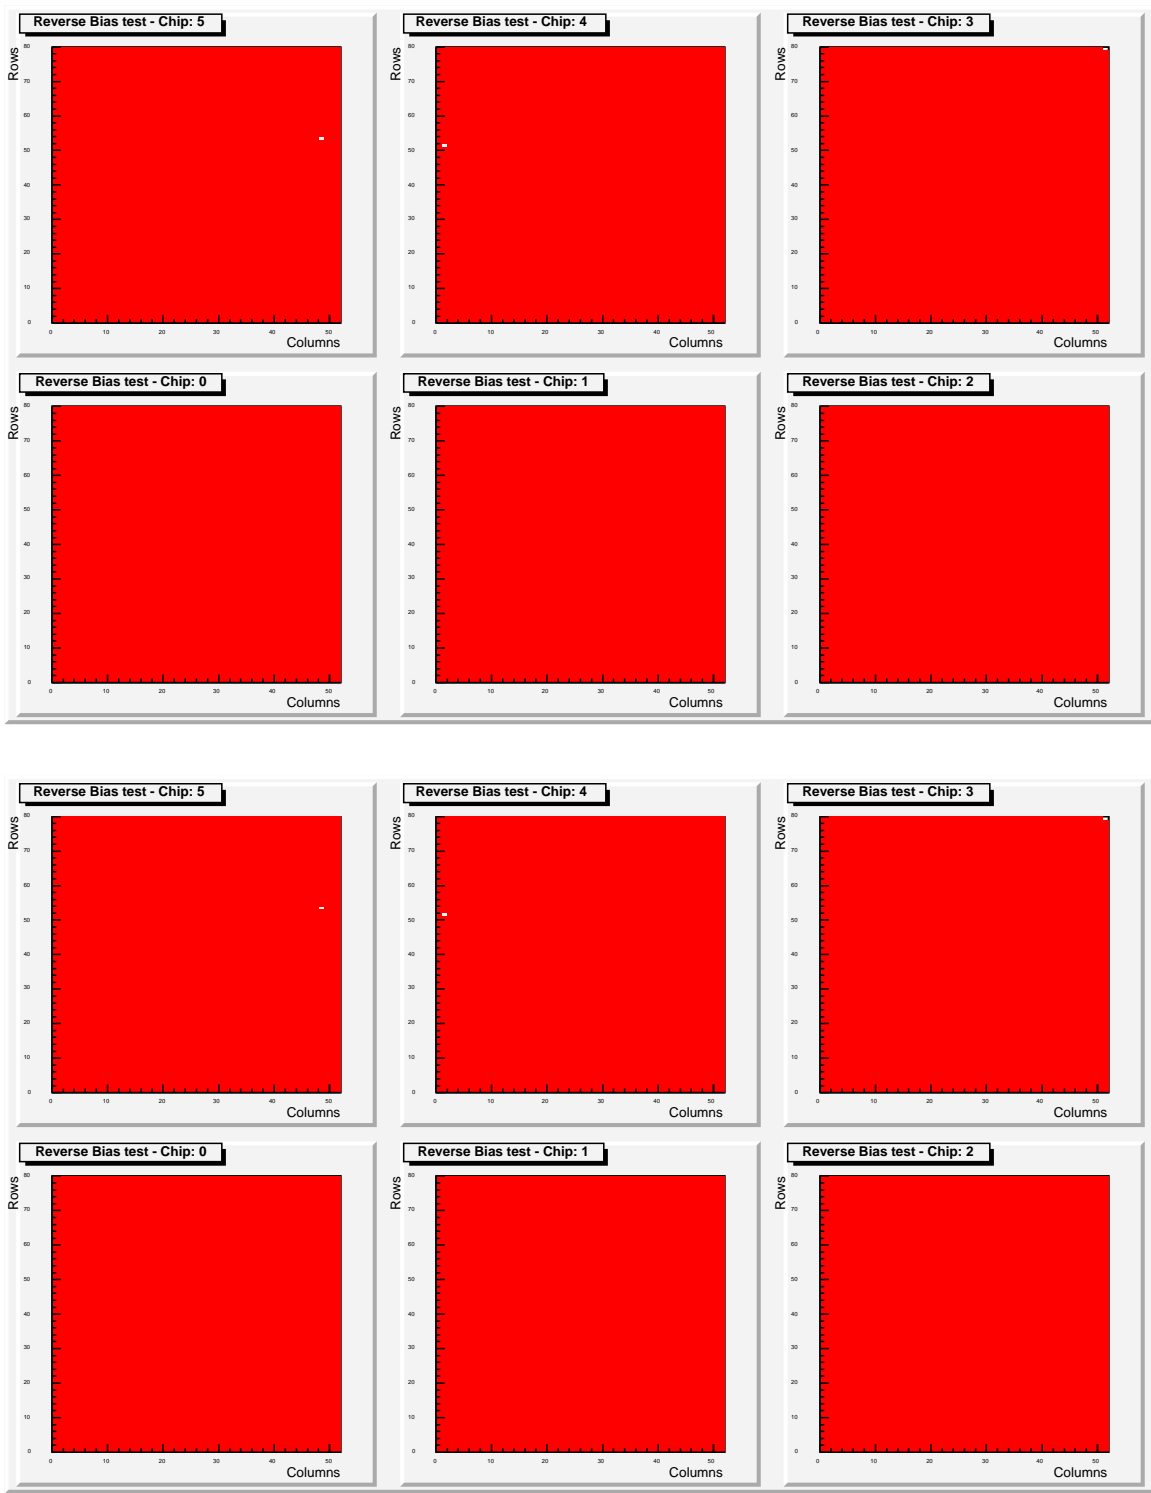
FIG. 8: Forward bias test results for P\_2x3T\_017\_C. The top plot was performed at  $+20^{\circ}$  C and the bottom plot was performed at  $-15^{\circ}$  C.

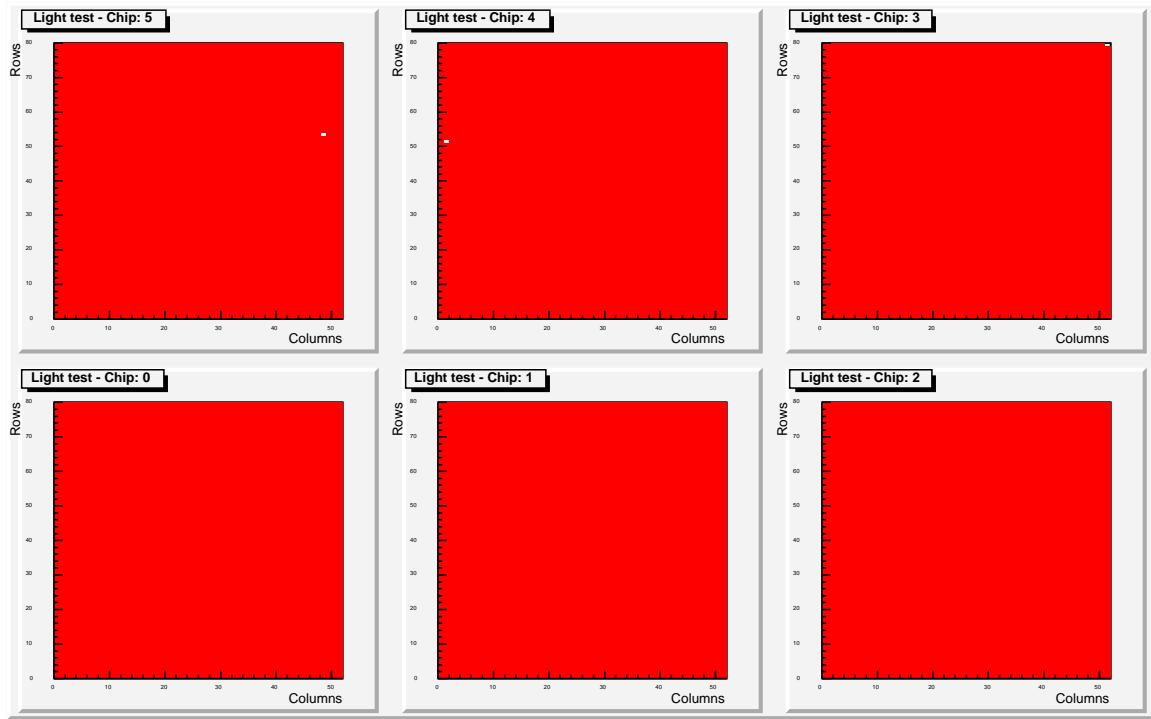
FIG. 9: SiDet light test results for P\_2x3T\_017\_C. The test was performed at  $+20^\circ$  C.

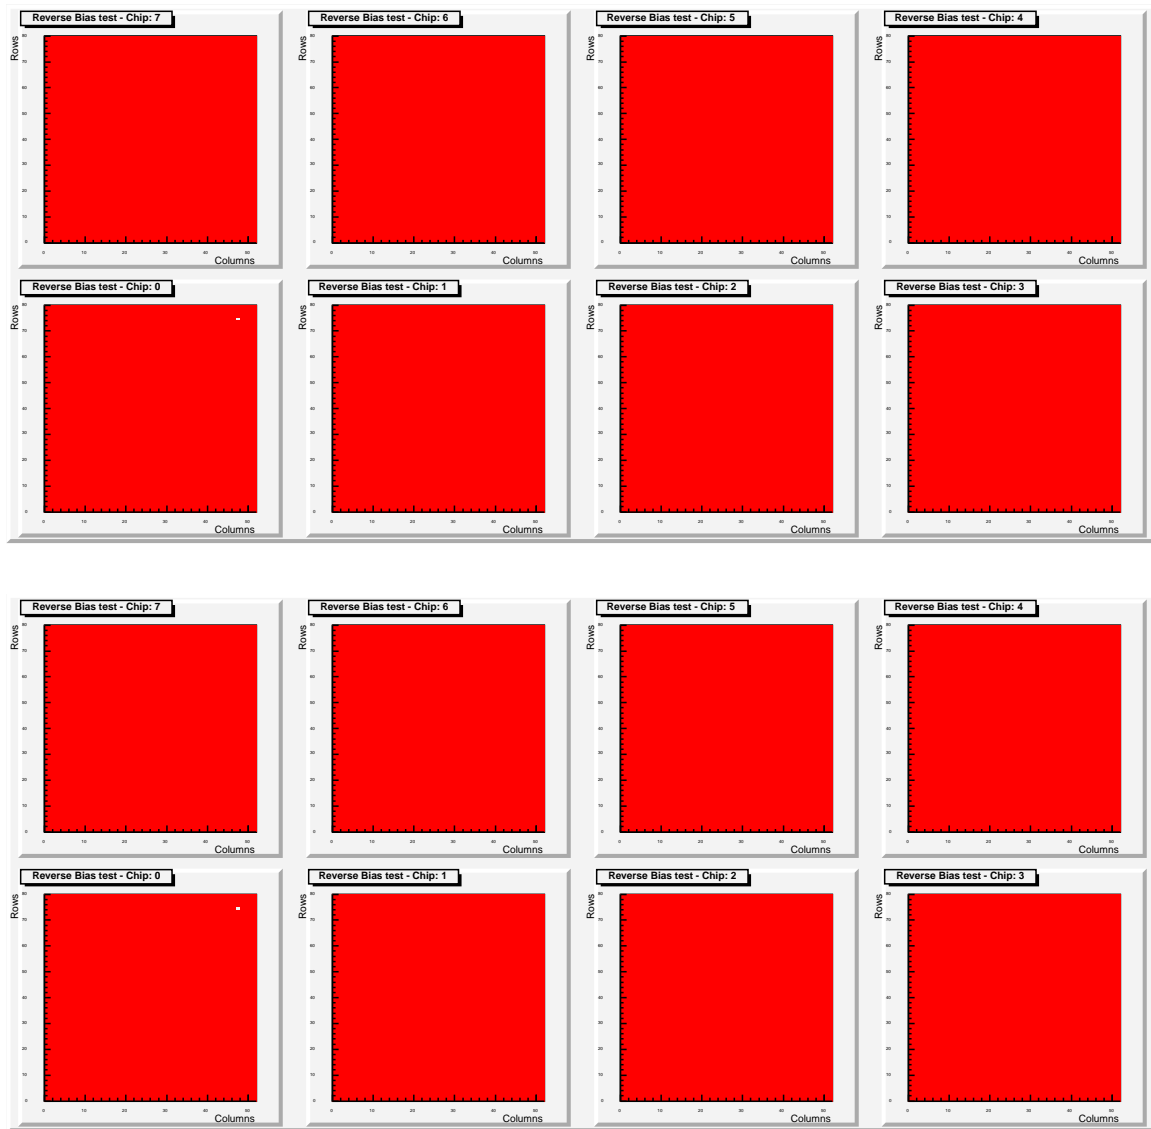
FIG. 11: Forward bias test results for P\_2x4T\_021\_C. The top plot was performed at +20° C and the bottom plot was performed at -15° C.

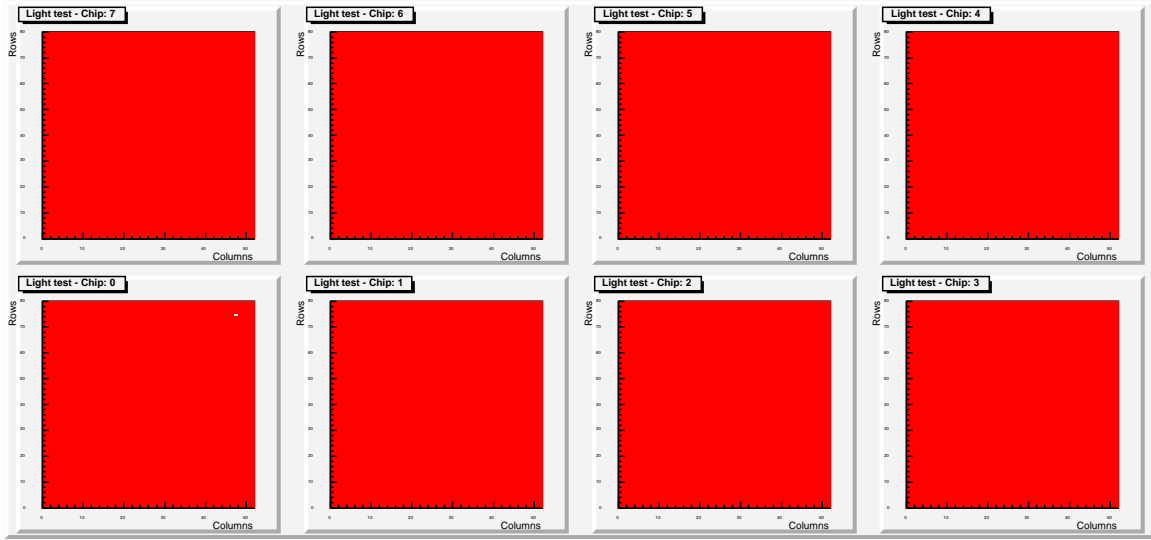
FIG. 12: SiDet light test results for P\_2x4T\_021\_C. The test was performed at +20° C.

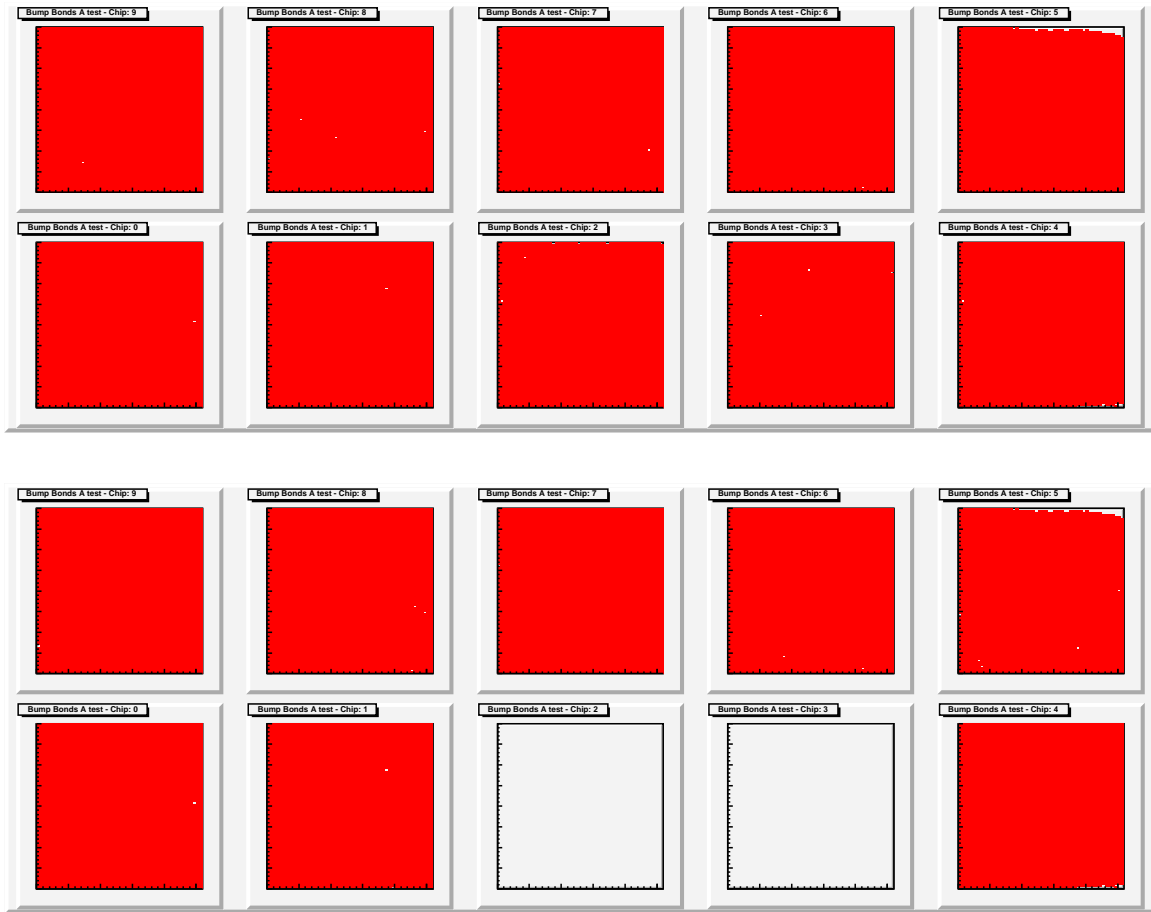
The quality of bump bonds on these modules appears to be quite good, and much improved over the RTI preproduction plaquettes. The two readout chips with the largest number of bad bump bonds have 62 and 17 bad bump bonds (according to the light and forward bias tests). These chip both occur on P\_2x5\_021\_C. This number of bad bump bonds represents 1.5% and 0.4% of the total pixels on the readout chip, respectively. The total number of bad

FIG. 13: Bump bond test A results for P\_2x5\_021\_C. The top plot was performed at +20° C and the bottom plot was performed at -15° C.

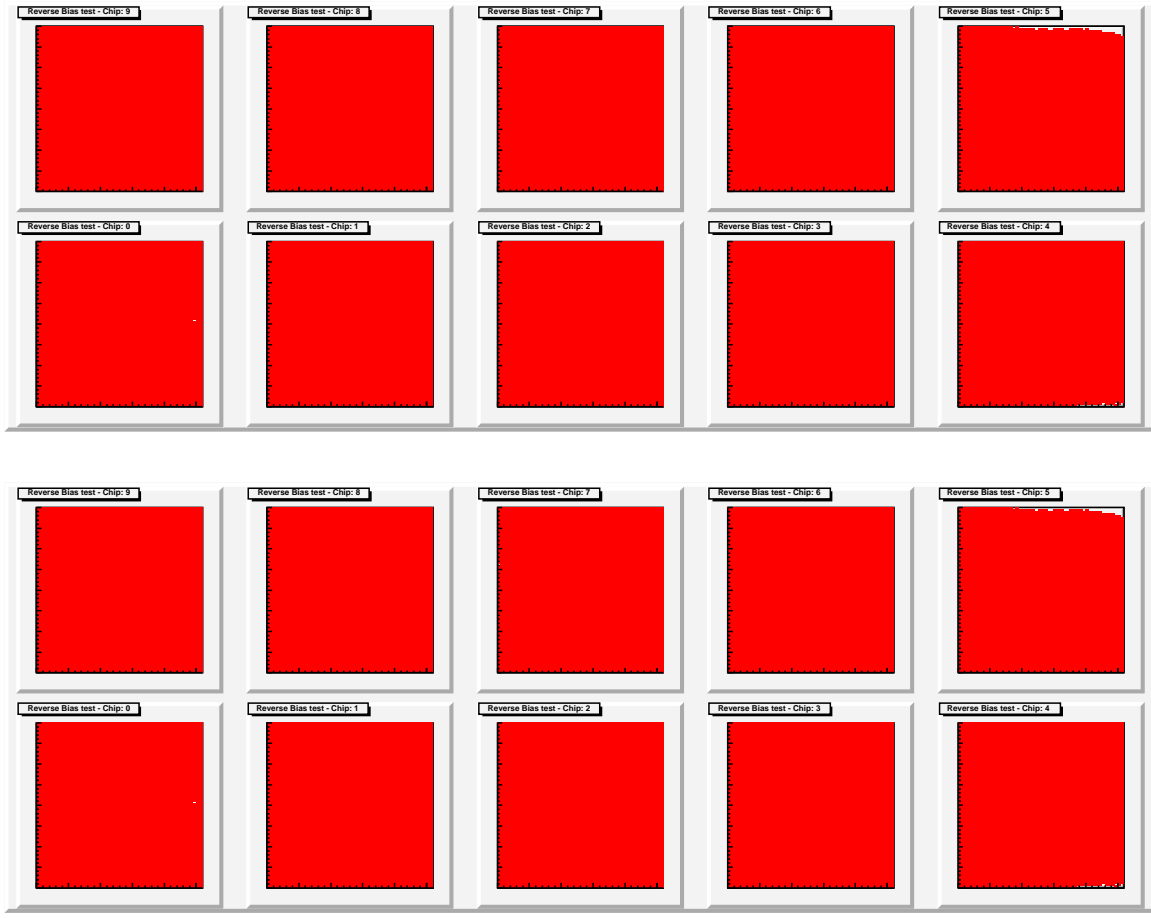
FIG. 14: Forward bias test results for P\_2x5\_021\_C. The top plot was performed at  $+20^{\circ}$  C and the bottom plot was performed at  $-15^{\circ}$  C.

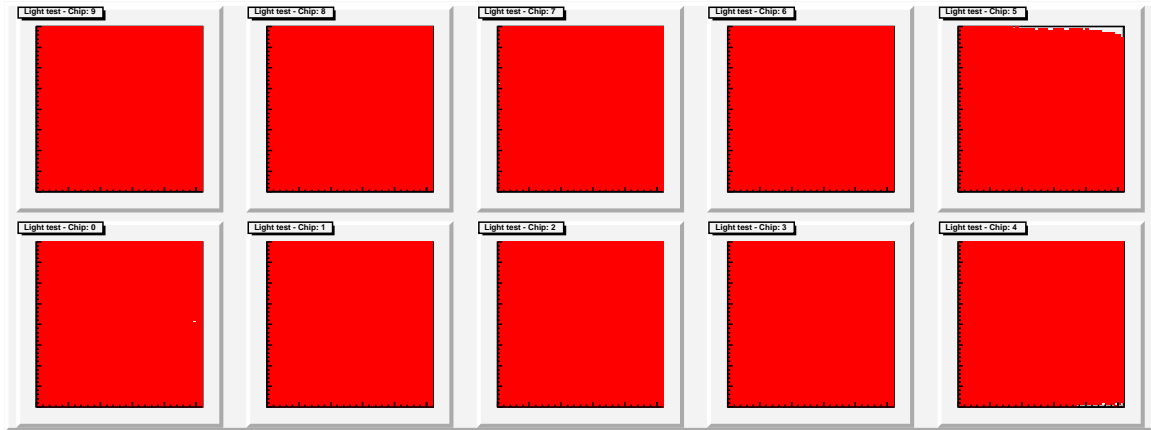
FIG. 15: SiDet light test results for P\_2x5\_021\_C. The test was performed at  $+20^{\circ}$  C.
